RESULTS AND INTERPRETATION OF ROCK ANCHOR TEST PROGRAM

EXISTING LOCKS AND DAM NO. 26
MISSISSIPPI RIVER, ALTON, ILLINOIS

Woodward-Clyde Consultants
Chicago, Illinois

15 July 1979

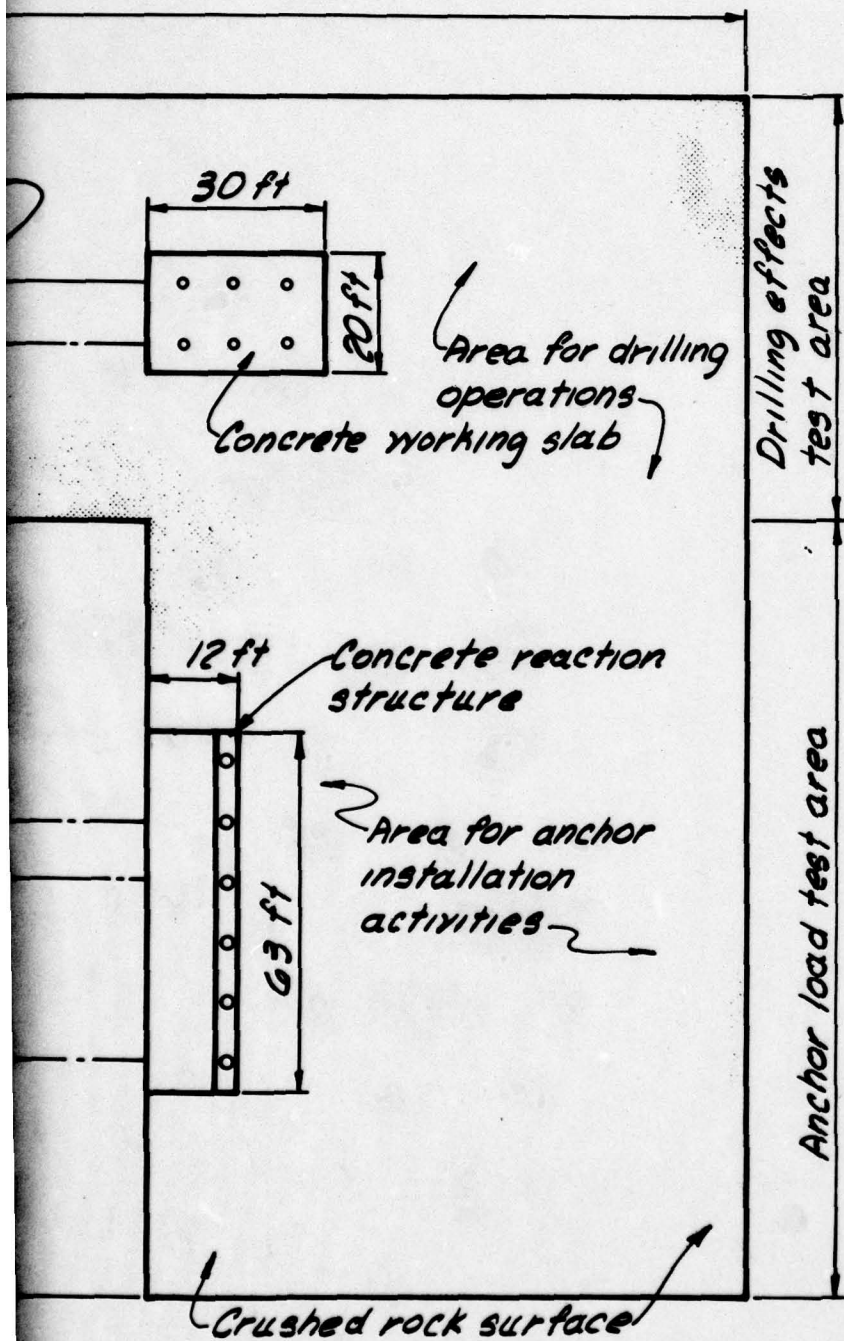
Fig. 2.2

ROCK ANCHOR TEST PROGRAM

CONFIGURATION OF TEST AREA

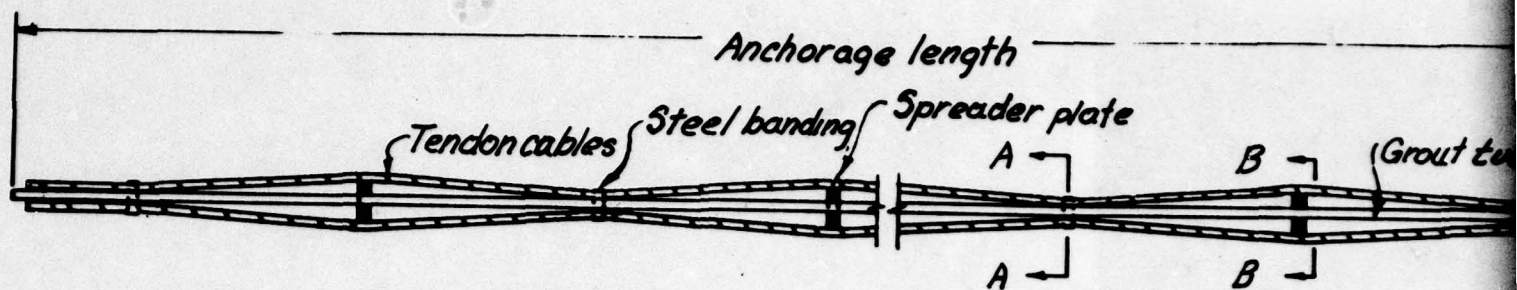
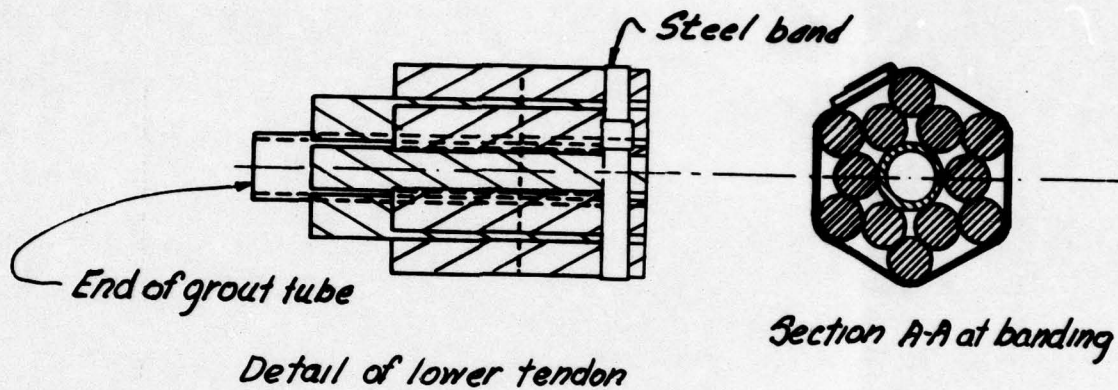
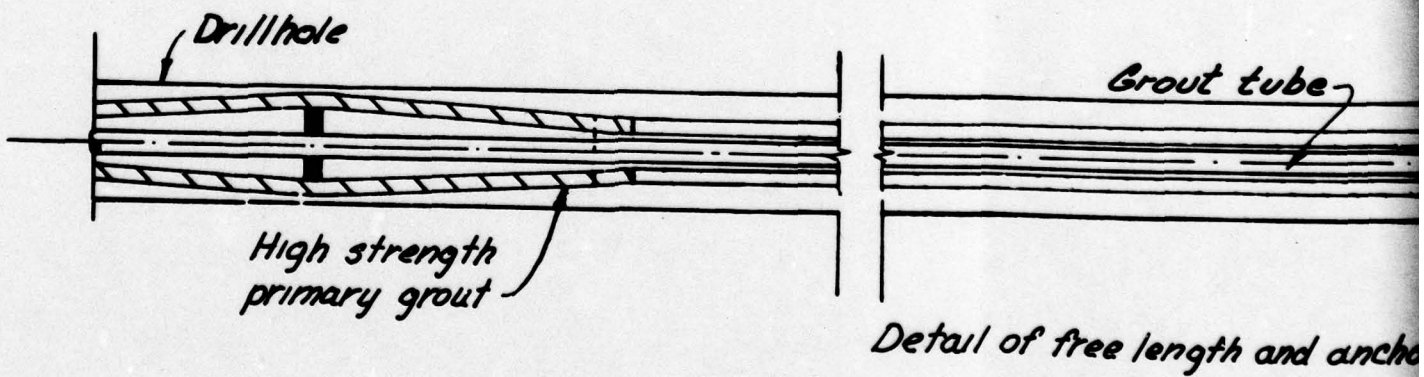
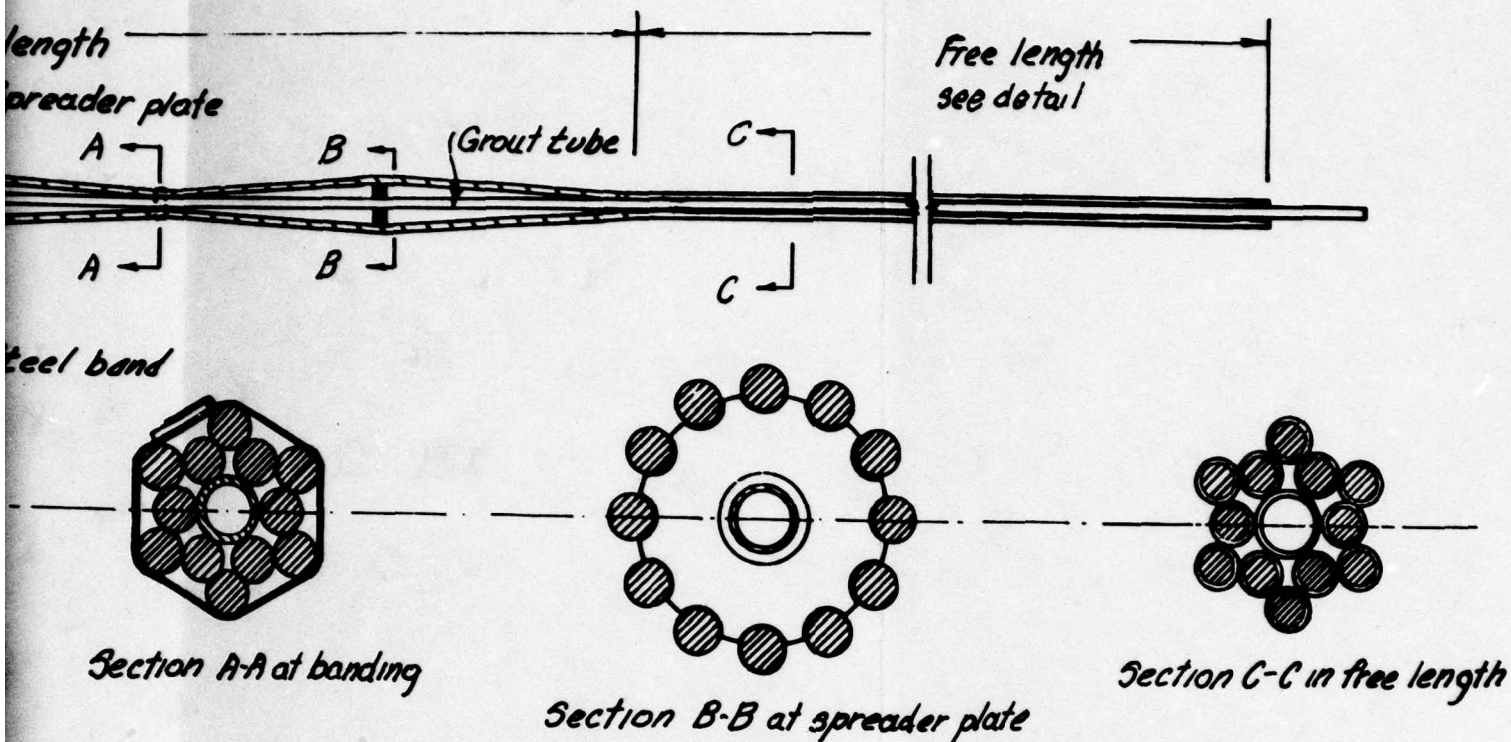
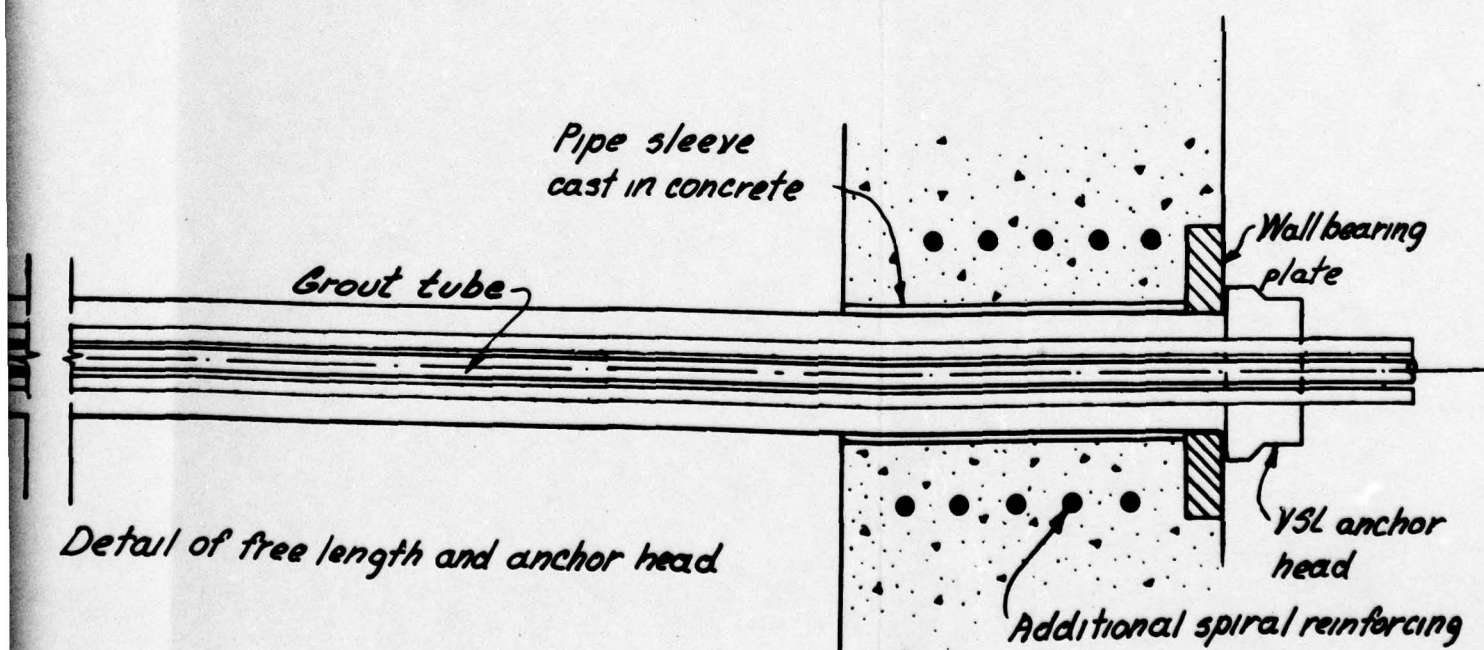
ROCK ANCHOR TEST PROGRAM	
TYPICAL VSL ANCHOR SYSTEM	
FOUNDATION INVESTIGATION AND TEST PROGRAM EXISTING LOCKS AND DAM No. 26 ST LOUIS DISTRICT, CORPS OF ENGINEERS. DACW43-78-C-0000	
Woodward-Clyde Consultants VCS225 Photo 2	Fig. 2.3

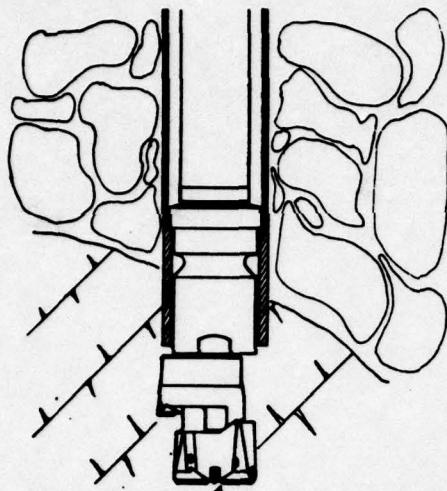
The pilot bit drills at the bottom of the hole. The reamer swings out automatically and reams the hole so that the casing can follow close behind the bit. The cuttings are transported upwards by means of air and water flushing inside the casing.

ROCK ANCHOR TEST PROGRAM PRINCIPLES OF ATLAS-COPCO ODEX SYSTEM

The drilling method used for installation of the test anchors and assessing drilling effects was the ODEX 165 system, Atlas-Copco. Compared with other available drilling methods, the ODEX system was considered the most appropriate to succeed in the demanding drilling conditions anticipated. Section 5.3 presents a detailed discussion on the ODEX system, its selection, and its performance during the test program. The drilling tools consisted of a 7-5/8-in.-dia casing, a 6-in.-dia bit, and an eccentric reamer that cut a 8-in.-dia hole. The bit and casing were driven by a down-the-hole (DTH) hammer and a rotation motor having a torque of 4400 ft-lb. The minimum compressed air requirements for operation of the hammer were 450 ft³/min at 150 lb/in². The air used to operate the DTH hammer was also used to flush the cuttings from the hole. After the casing was seated in rock, the drill hole was continued by standard rotary-percussion, 5.5- and 6-in.-dia rock bits. Figure 2.4 shows the sequence of drilling with the ODEX system.

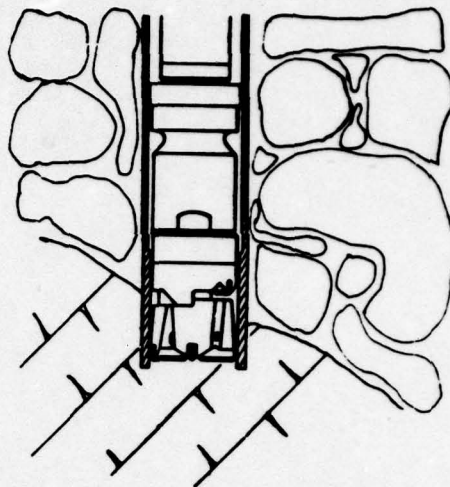
When drilling is completed, the drill bit is rotated in the other direction, so that the reamer is folded in. With the reamer in this position, the drilling equipment can be withdrawn through the casing.

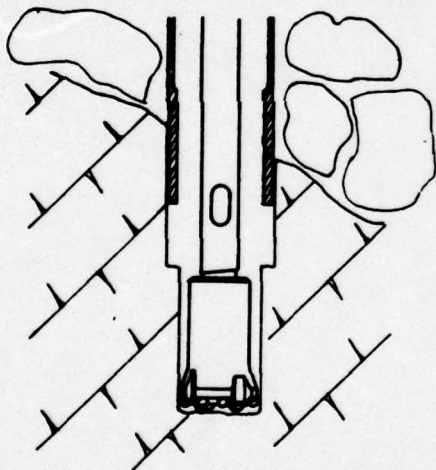
Drilling is continued with standard rock drilling equipment through the casing.

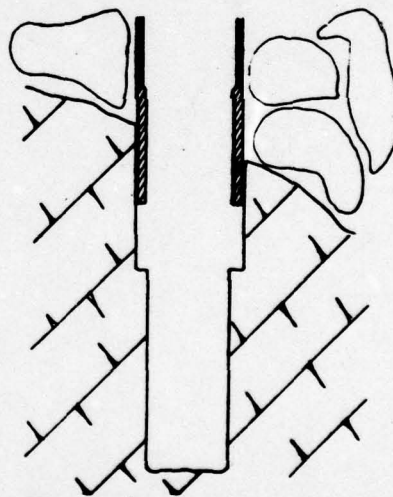
The casing is left in place in the hole to stabilize the walls until the anchor is installed.

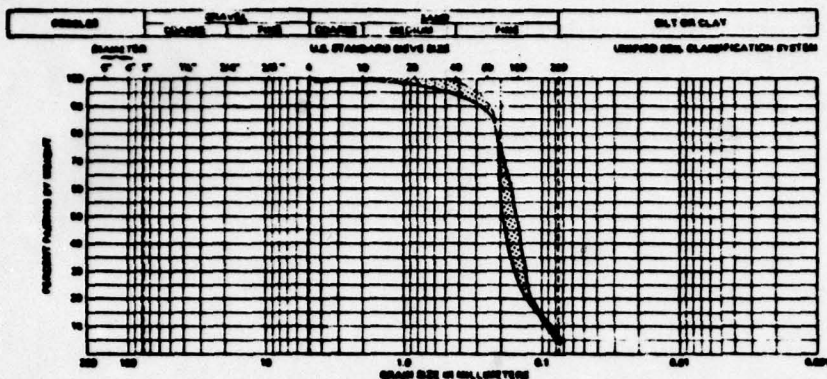
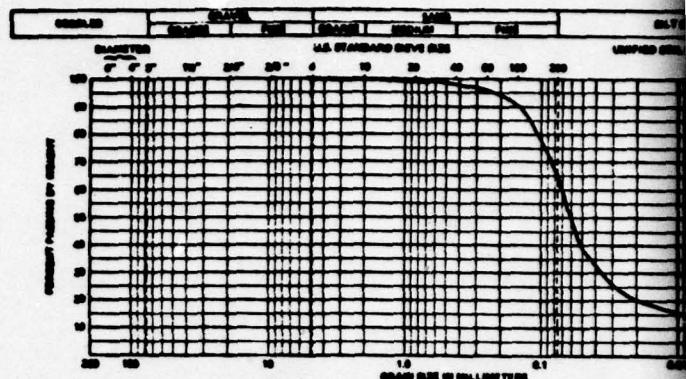
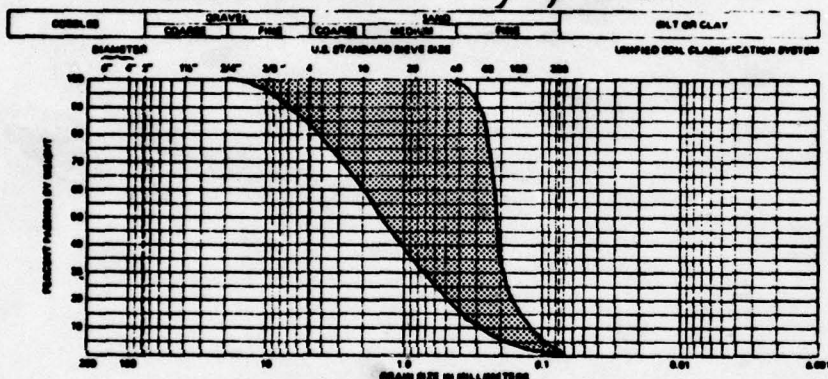
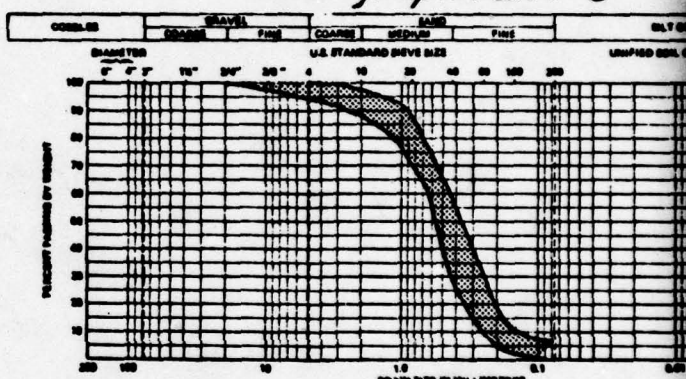
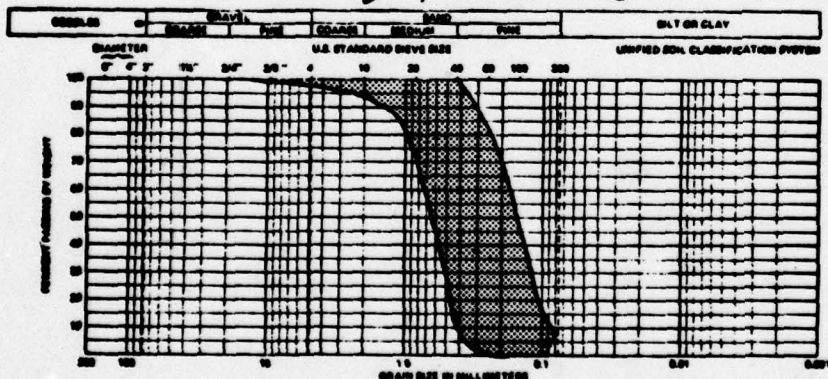
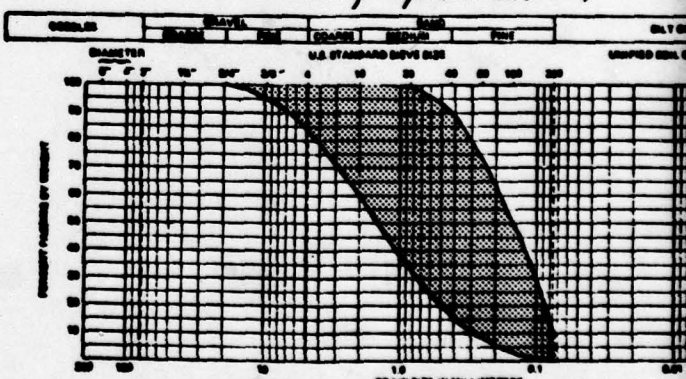
<p>ROCK ANCHOR TEST PROGRAM</p> <p>GRAIN SIZE</p> <p>DISTRIBUTION OF VARIOUS</p> <p>STRATIGRAPHIC UNITS</p>	
<p>FOUNDATION INVESTIGATION AND TEST PROGRAM</p> <p>EXISTING LOCKS AND DAM No. 26</p> <p>ST LOUIS DISTRICT, CORPS OF ENGINEERS.</p> <p>DACW43-78-C-0000</p>	
<p> Woodward-Clyde Consultants</p> <p>YTCSS Phase II</p>	<p>Fig 3.3</p>

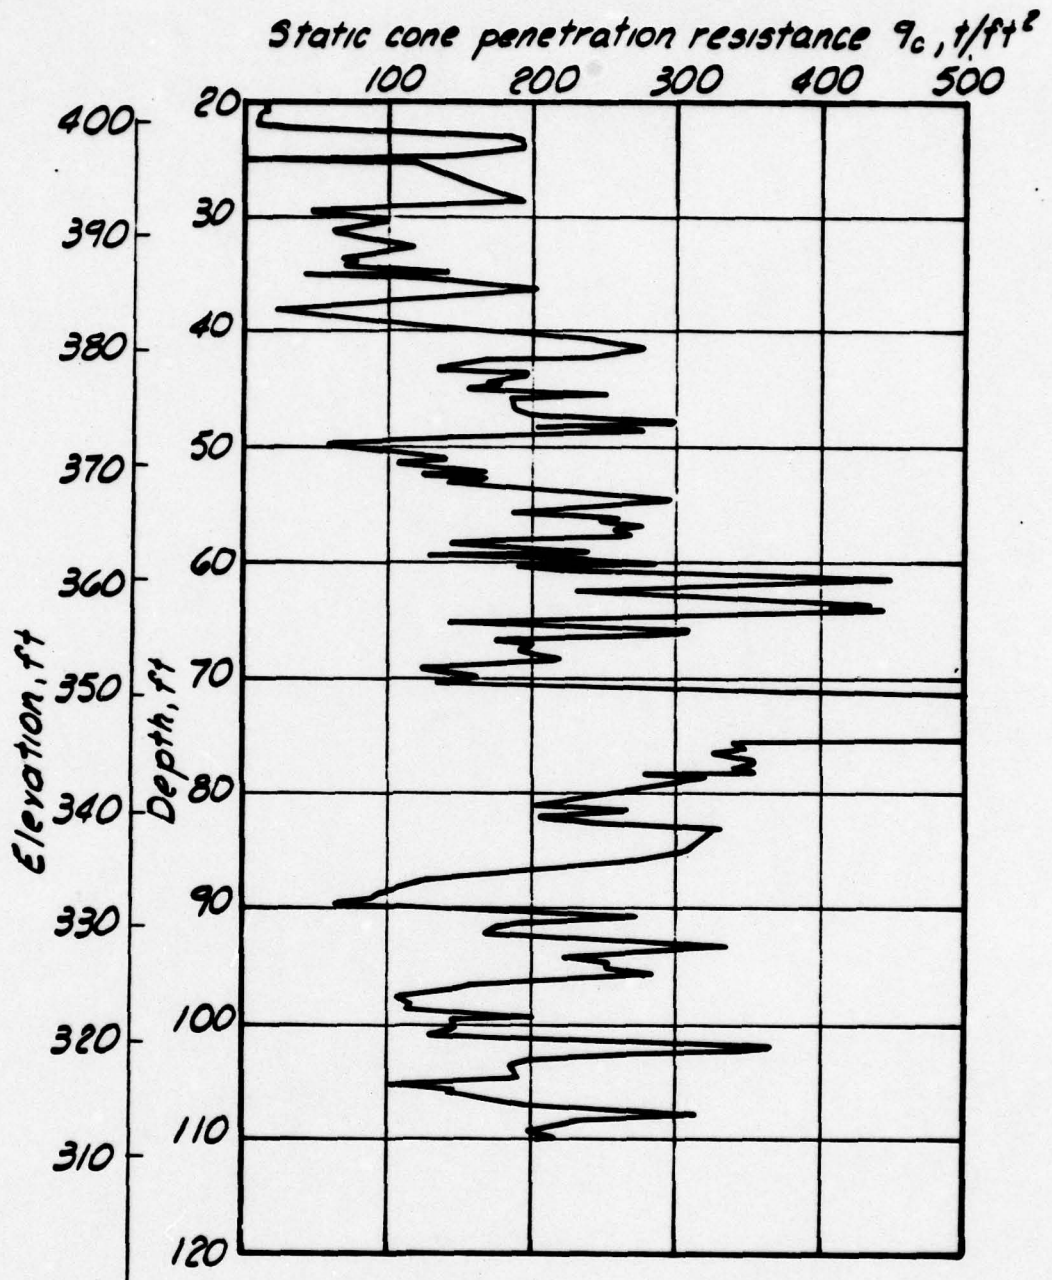
ROCK ANCHOR TEST PROGRAM	
STATIC CONE PENETRATION RESISTANCE PROFILE BEFORE ANCHOR INSTALLATION	
<small>FOUNDATION INVESTIGATION AND TEST PROGRAM EXISTING LOCKS AND DAM No. 26 ST LOUIS DISTRICT, CORPS OF ENGINEERS. DACW43-78-C-0000</small>	
Woodward-Clyde Consultants <small>YTC020 Photo IX</small>	Fig 3.4

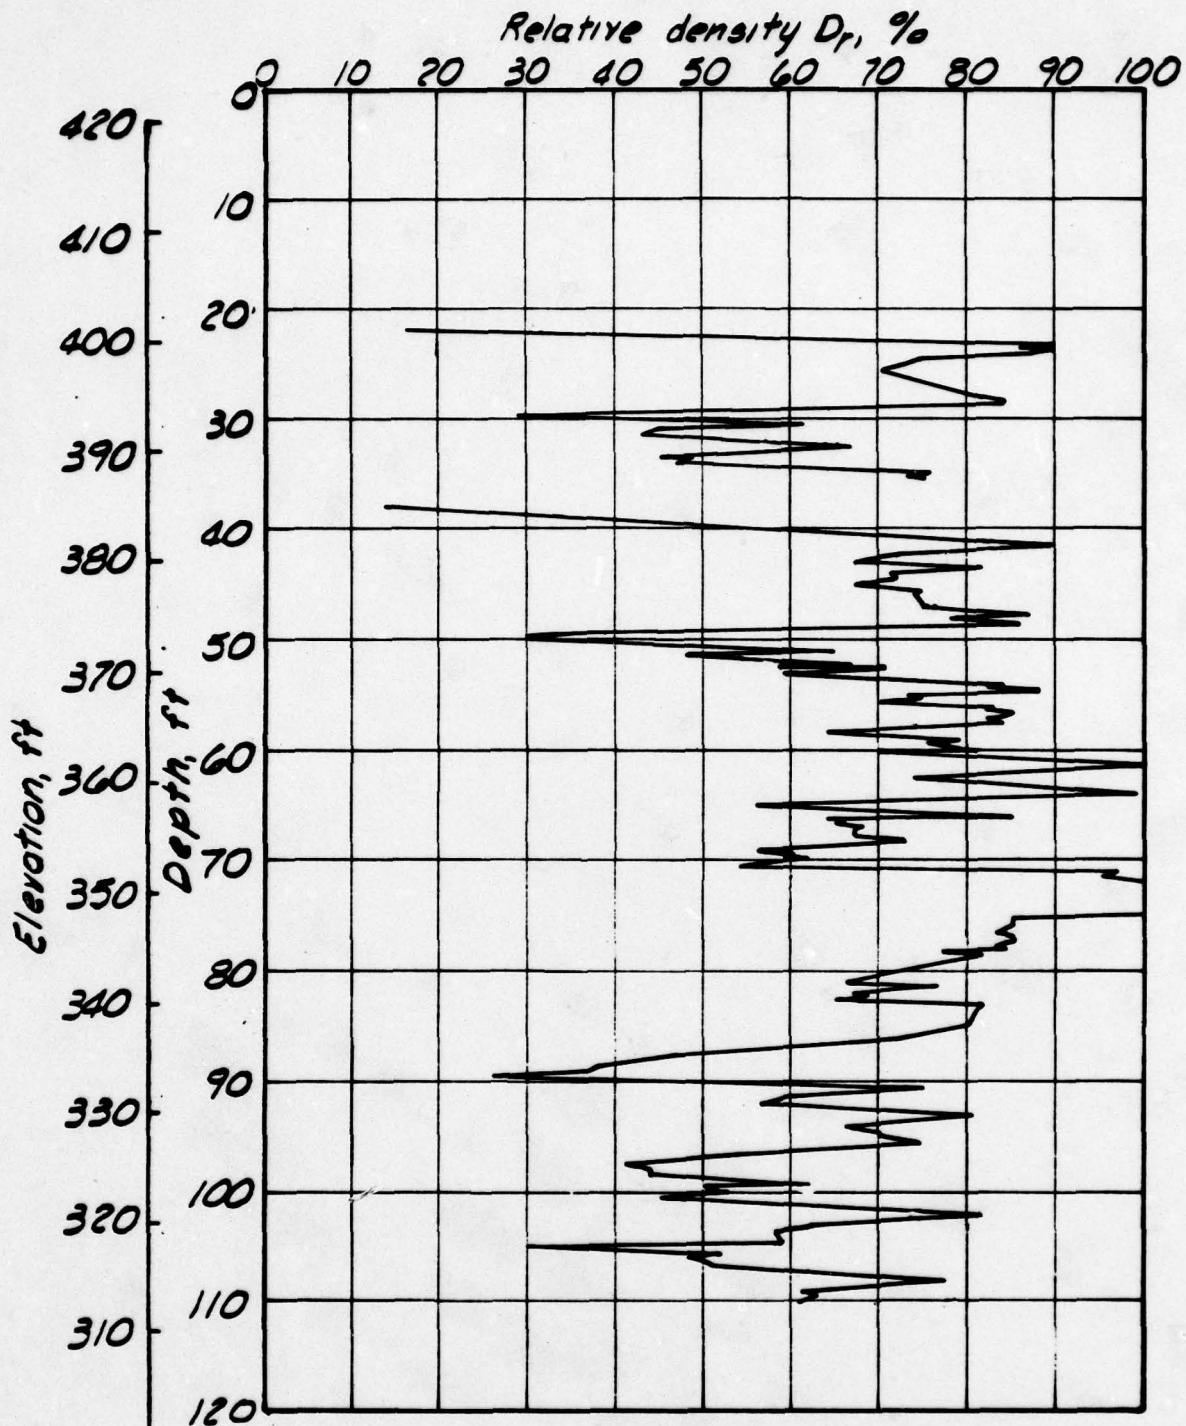
— D_r derived from static cone penetration test in boring DP-C1, using Schmertmann (1976) Correlation

ROCK ANCHOR TEST PROGRAM	
RELATIVE DENSITY PROFILE BEFORE ANCHOR INSTALLATION	
FOUNDATION INVESTIGATION AND TEST PROGRAM	
EXISTING LOCKS AND DAM No. 26	
ST. LOUIS DISTRICT, CORPS OF ENGINEERS.	
DACW43-78-C-0008	
Woodward-Clyde Consultants VTC025 Phase II	Fig. 3.5

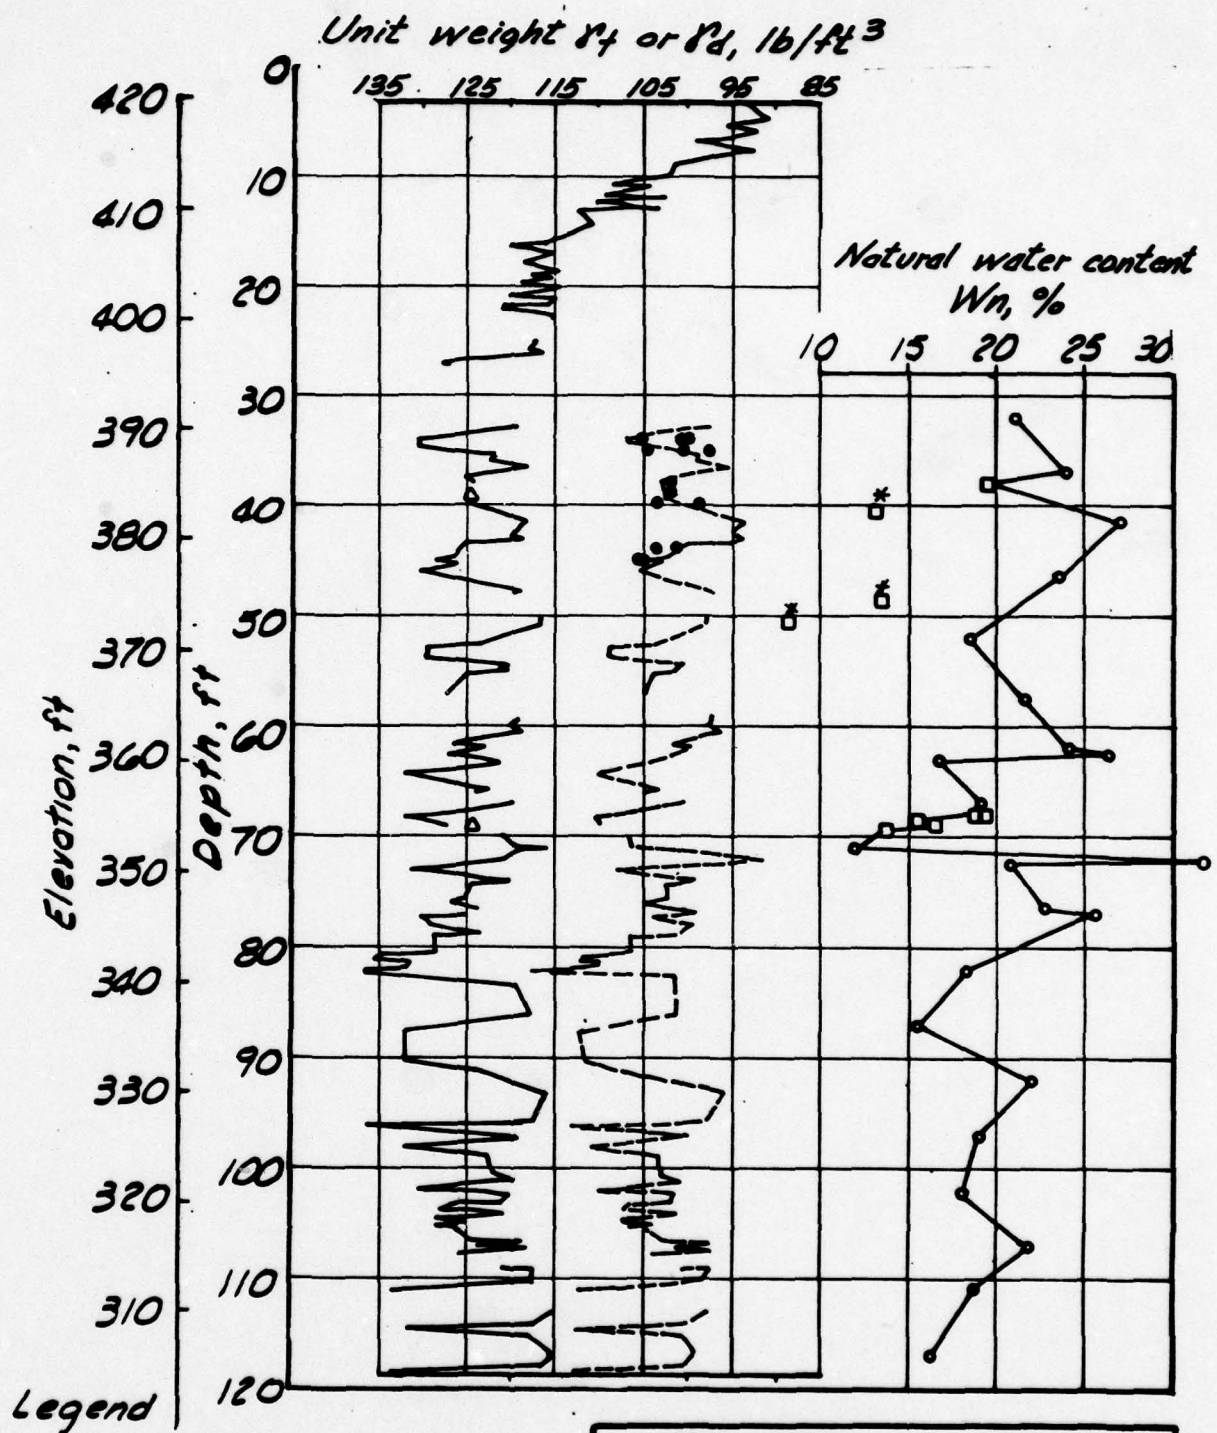
- Unit weight
- Total-(nuclear density probe)
 - △ Total-(Hvorslev sample)
 - Dry-(nuclear density probe)
 - Dry-(Osterberg sample)
- Natural water content
- Split spoon sample, (disturbed)
 - Hvorslev sample
 - * Drainage allowed in tube

ROCK ANCHOR TEST PROGRAM
PROFILE AT BORING DP-D1
OF NATURAL
DRY UNIT WEIGHT
AND WATER CONTENT

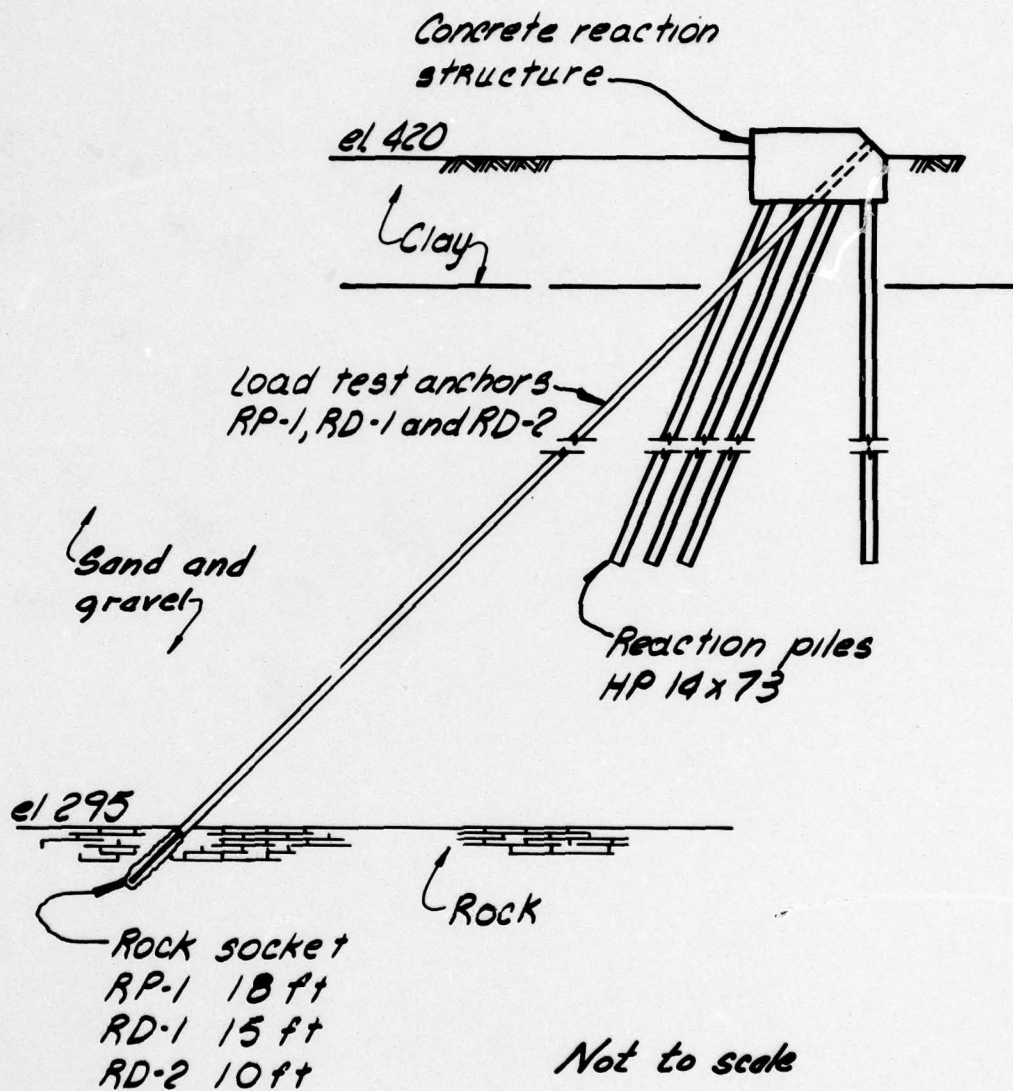
ROCK ANCHOR TEST PROGRAM

SECTION AT
ROCK ANCHOR LOAD TEST

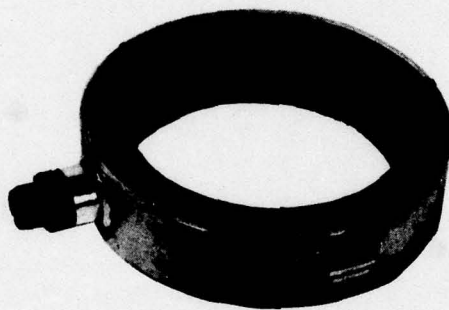
Technical Data
Model PC-300M
Capacity 800 Kips
Sensitivity 0.05%
Outside dia 10-in
Inside dia 7 1/4-in
Height 6-in.
Weight 20-lb

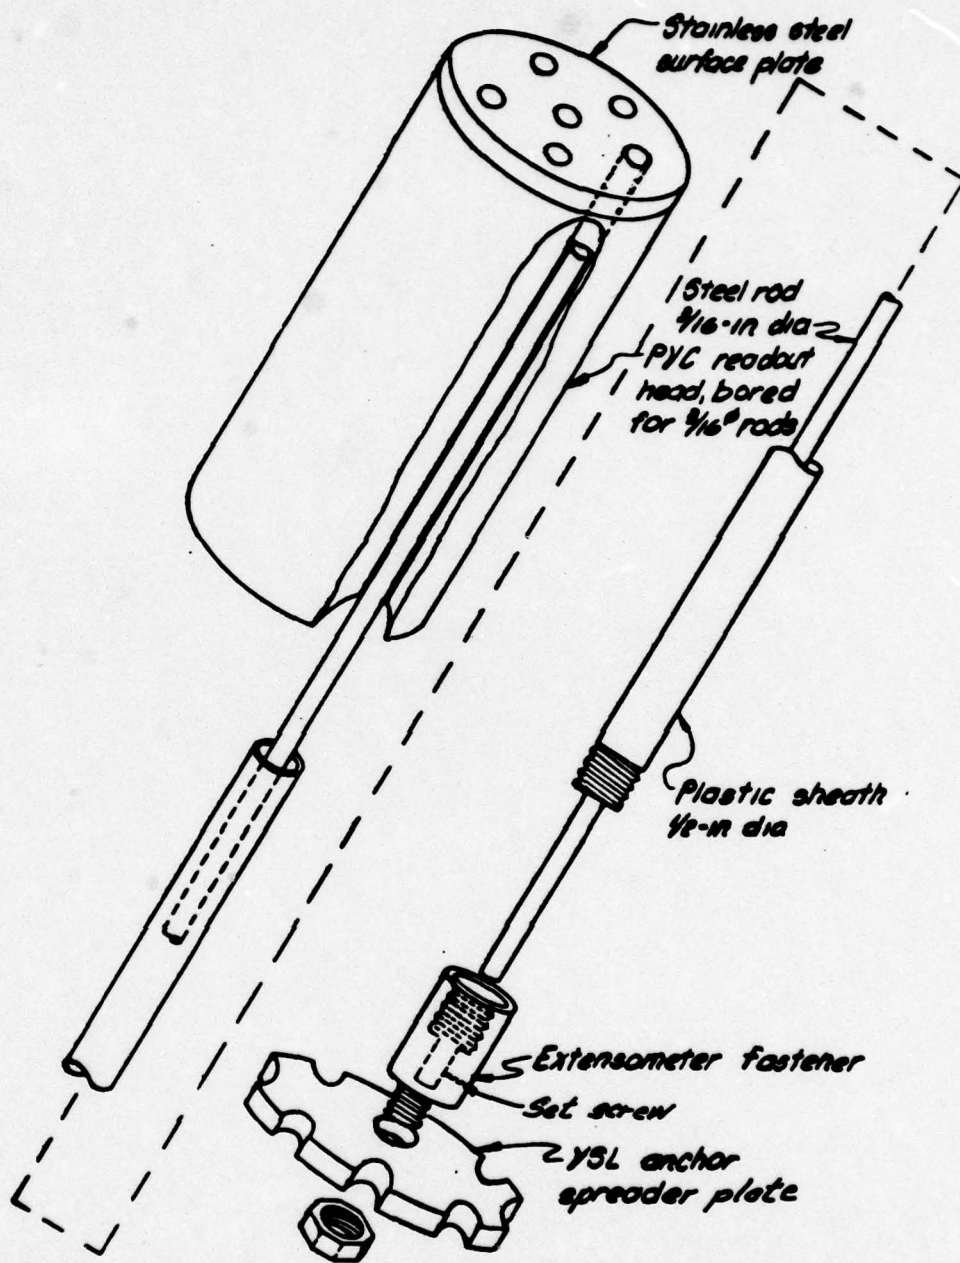
<p>ROCK ANCHOR TEST PROGRAM</p>	
<p>TYPICAL ROD EXTENSOMETER</p>	
<p>FOUNDATION INVESTIGATION AND TEST PROGRAM</p>	
<p>EXISTING LOCKS AND DAM No. 26</p>	
<p>ST LOUIS DISTRICT, CORPS OF ENGINEERS.</p>	
<p>DACW43-78-C-0000</p>	
<p>

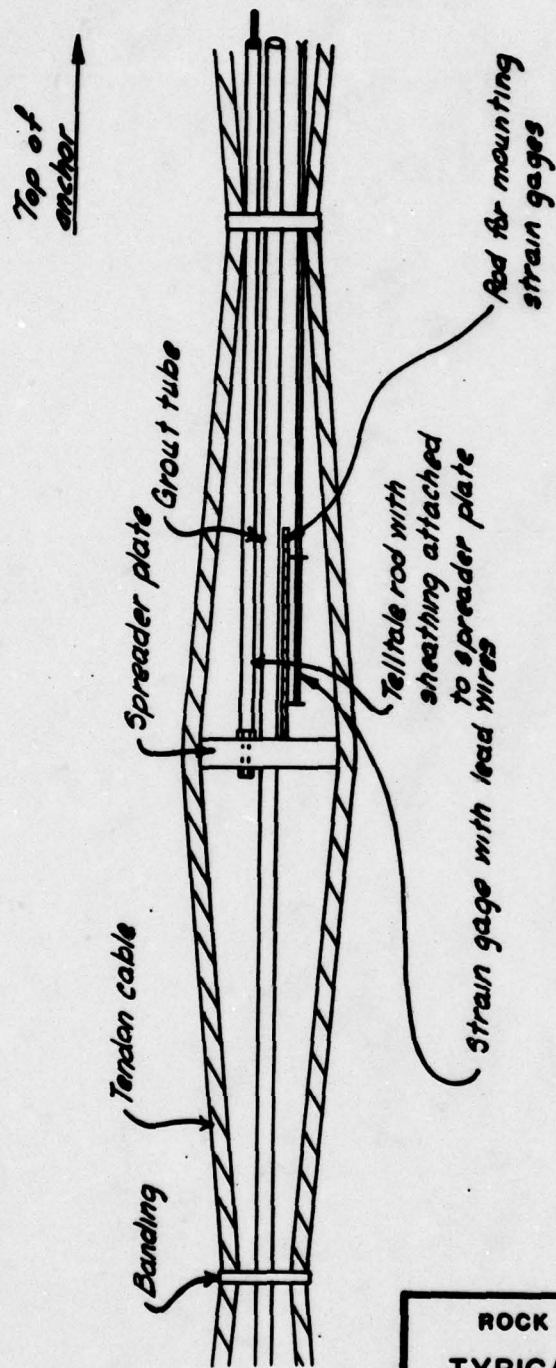
ROCK ANCHOR TEST PROGRAM
TYPICAL INSTRUMENTATION
WITHIN ANCHORAGE ZONE

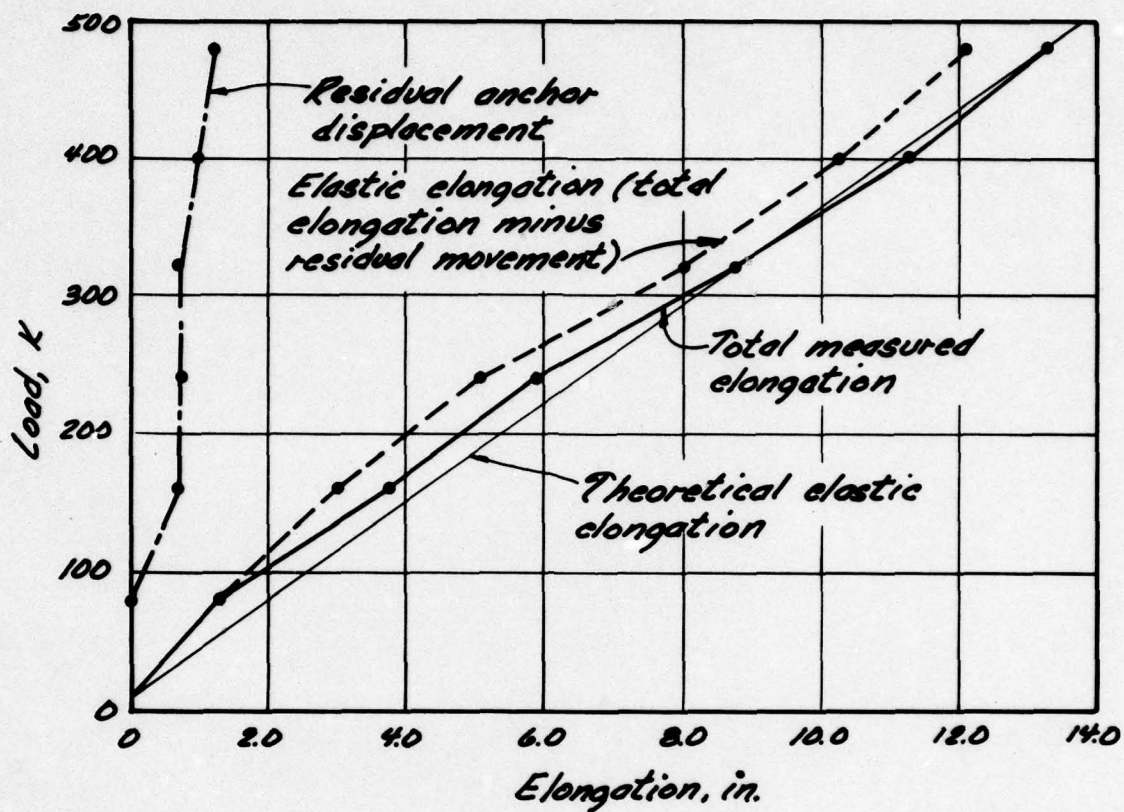
Woodward-Clyde Consultants VTC025 Phase III	Fig 4.8

Anchor data

No. of strands 17
 E of steel, K/in^2 29400
 Total length, ft 198.0
 Free length, ft 180.0
 Anchorage length, ft 18.0
 Grout strength lb/in^2 5479
 (7 days)

None of the three anchors tested failed. The prototype anchor, having an 18-ft-long anchorage length in rock, sustained a test load of 480 k (20 percent of the design load); at that load, the total tendon elongation was 13.3 in. The two special design anchors, having either a 10- or 15-ft-long anchorage length in rock, sustained a test load of 800 k (twice the design load); at that load, the total tendon elongation for both anchors was 15.4 in. and 16.3 in. respectively. These results are in good agreement with predictions made at the design stage.

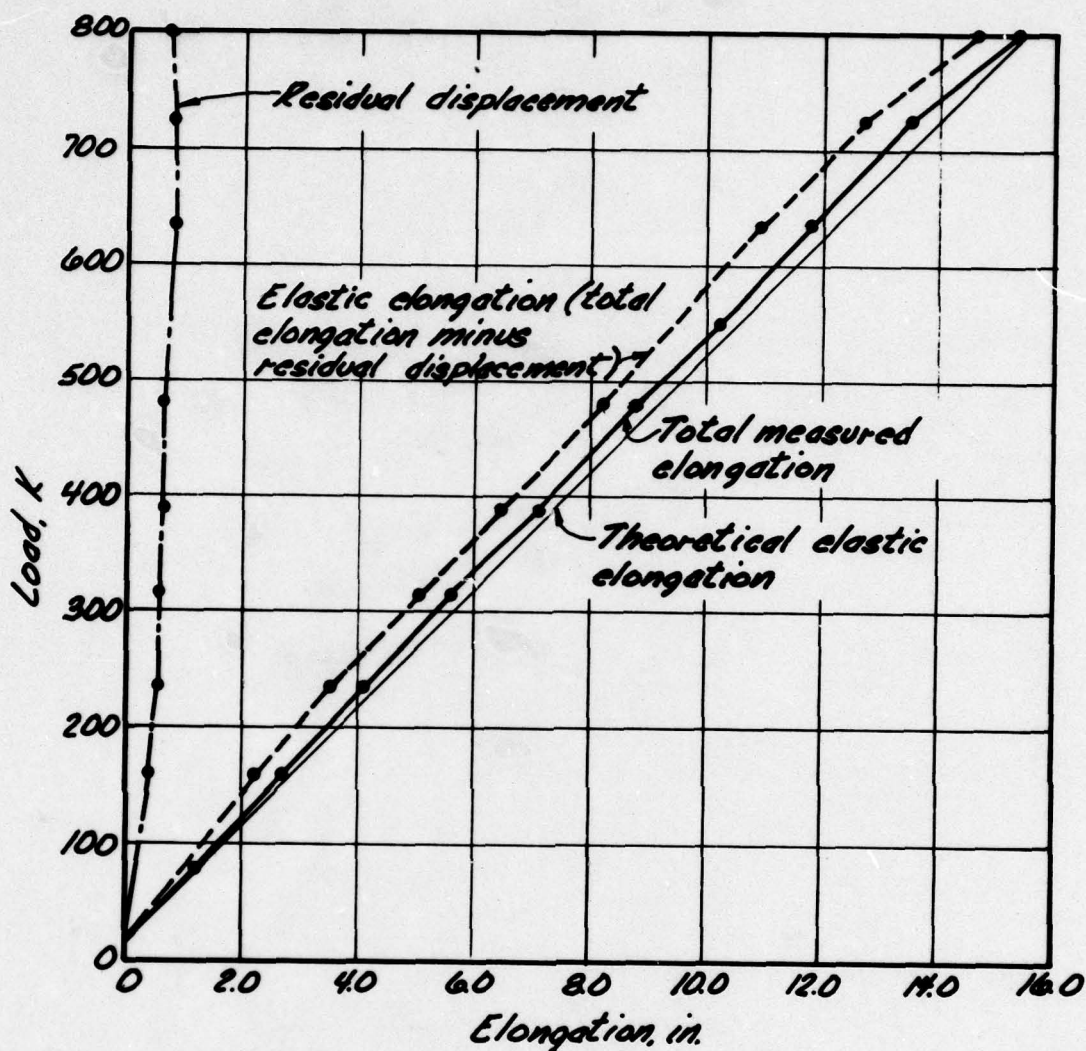
Fig 4.9

Anchor data

No. of strands 25
 E of steel, K/in.² 29400
 Total length, ft 199.6
 Free length, ft 184.6
 Anchorage length, ft 15.0
 Grout strength, lb/in.² 62.92
 (7 days)

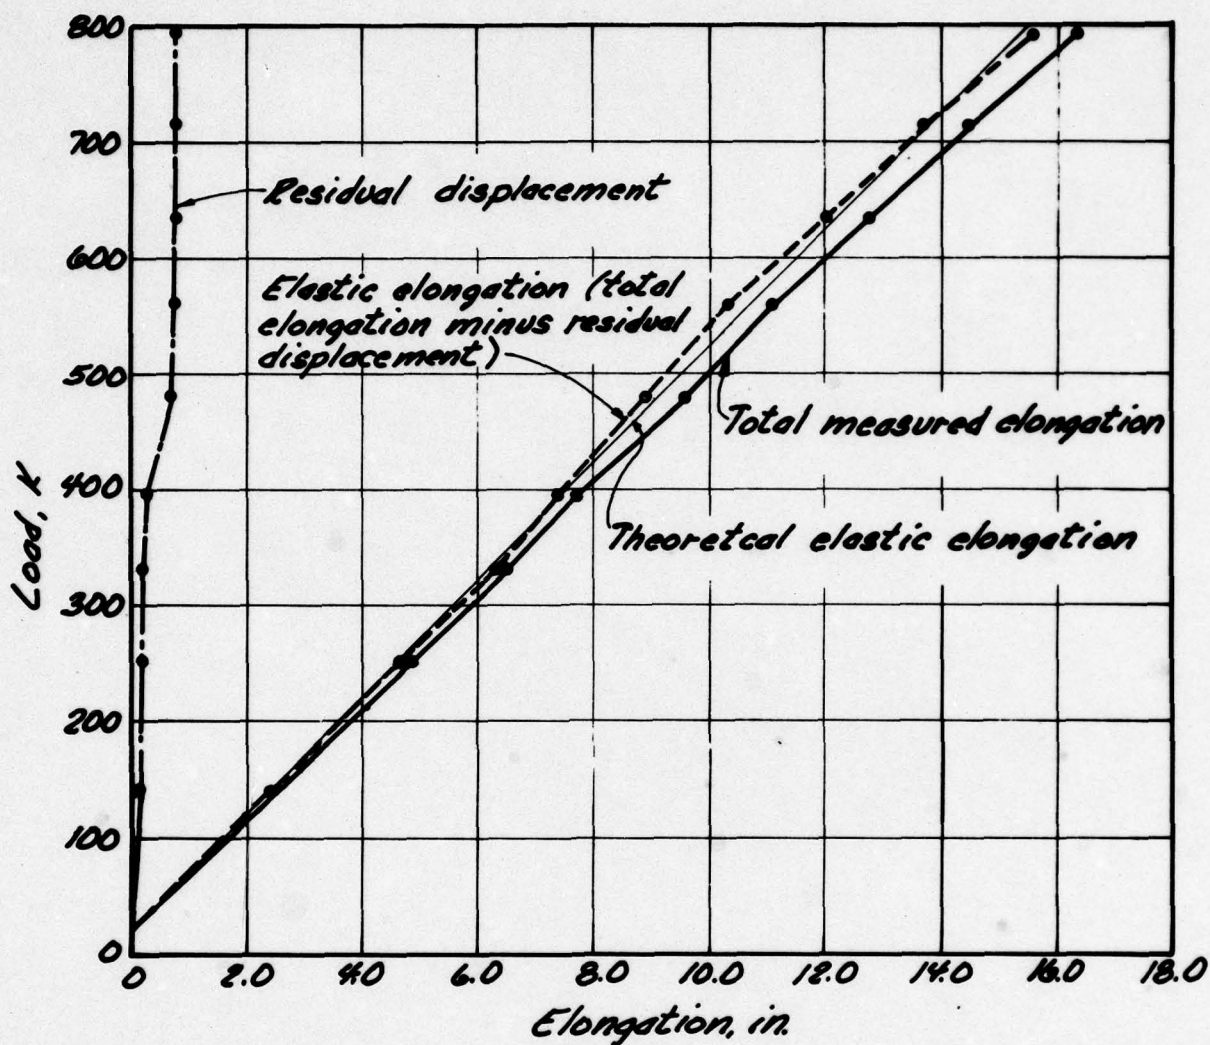
Fig 4.10

Anchor data

No. of strands 24
 E of steel, K/in^2 29400
 Total length, ft 188.0
 Free length, ft 178.0
 Anchorage length, ft 10.0
 Grout strength, lb/in^2 *

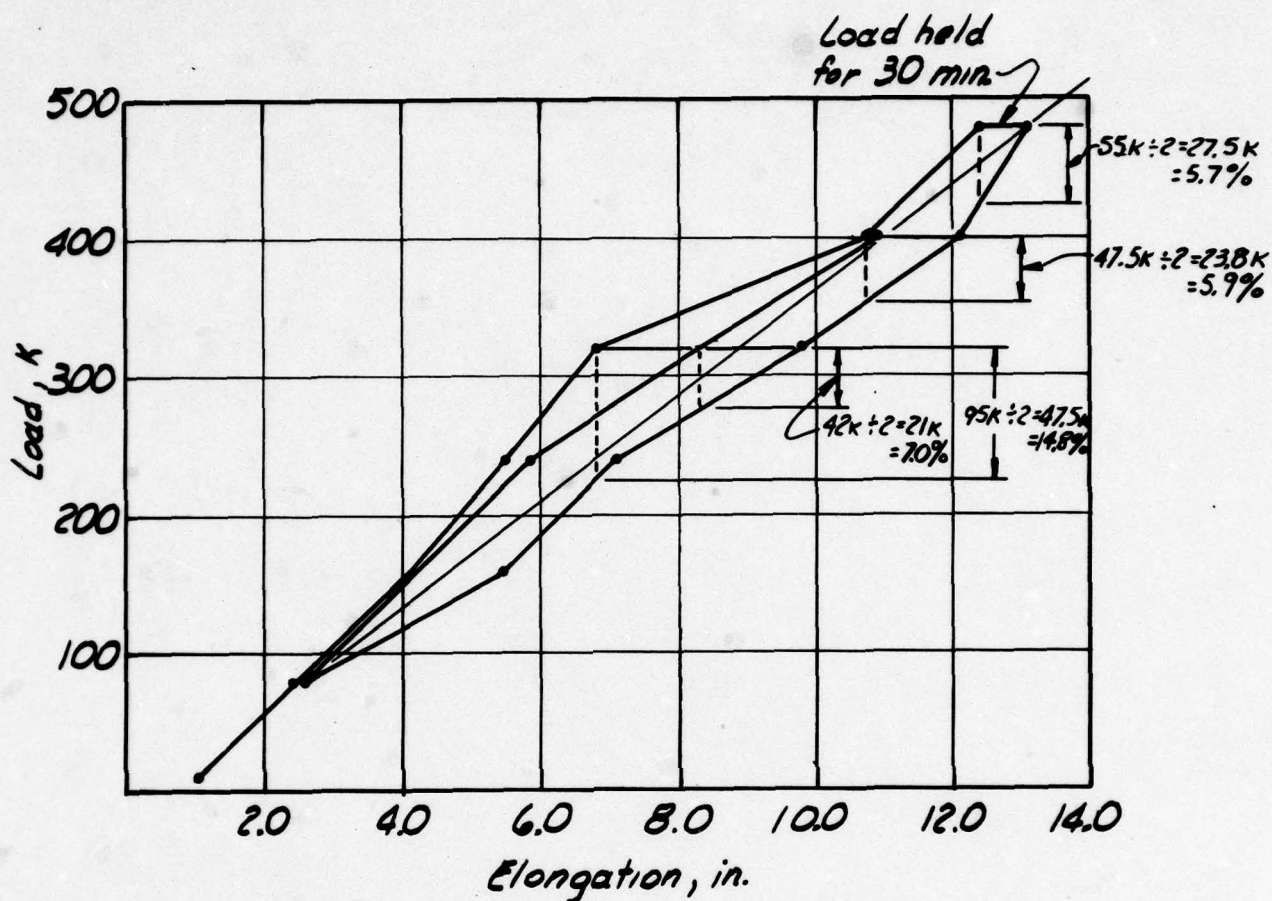
- (1) The test cycle shown is for the 480-k load increment
- (2) Friction losses were analyzed by the cycle method of Fenoux and Portier (1972)

ROCK ANCHOR TEST PROGRAM	
DETERMINATION OF FRICTION LOSSES ANCHOR RP-1	
FOUNDATION INVESTIGATION AND TEST PROGRAM EXISTING LOCKS AND DAM No. 28 ST. LOUIS DISTRICT, CORPS OF ENGINEERS. DACW43-78-C-0005	
Woodward-Clyde Consultants Y7C025 phase III	Fig. 4.11

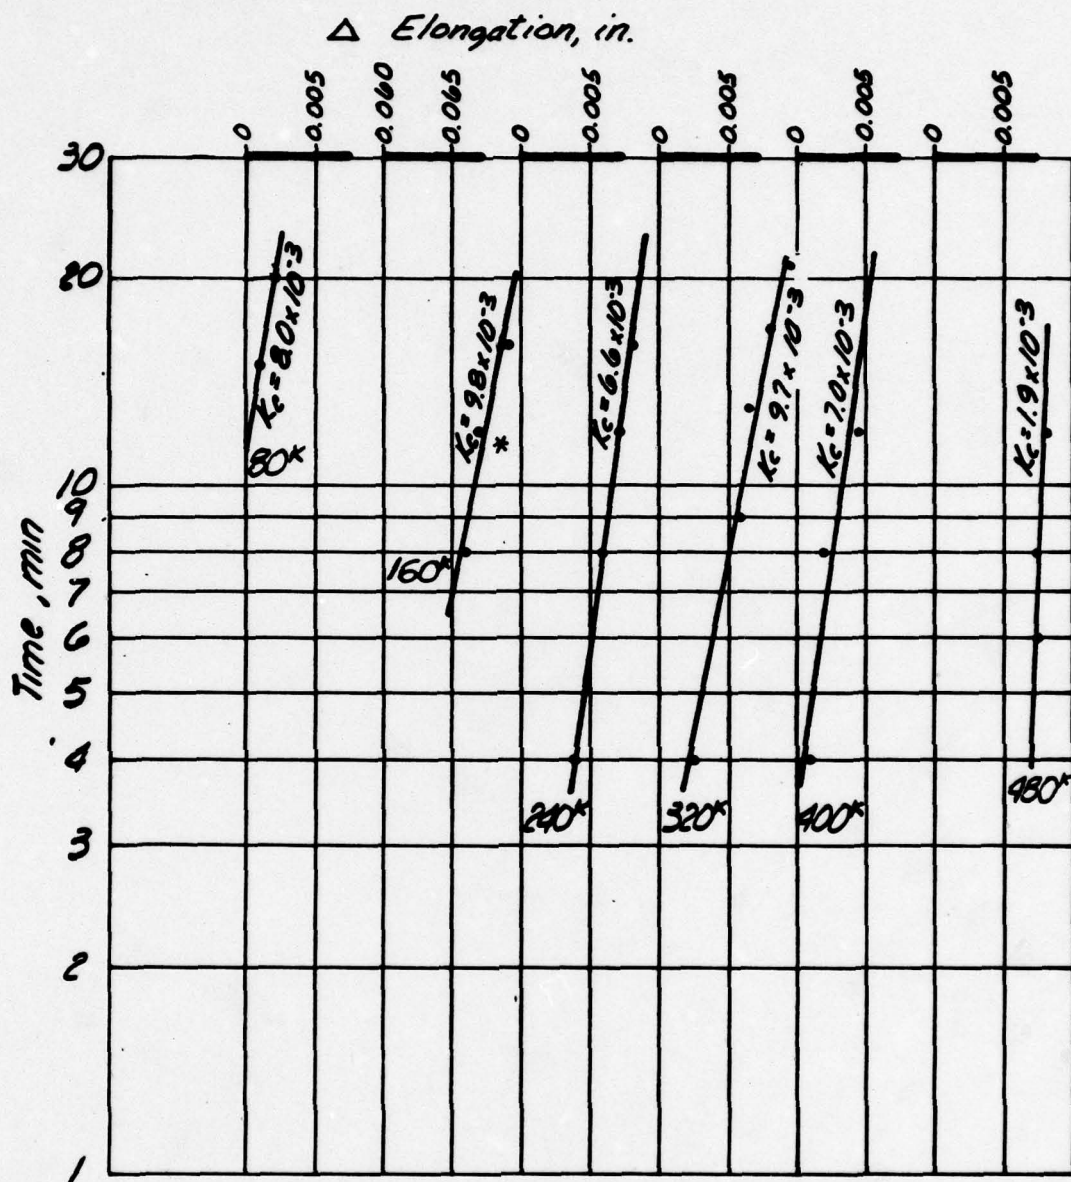
Creep coefficient

$$K_c = \frac{\Delta_2 - \Delta_1}{\log \frac{t_2}{t_1}}$$

ROCK ANCHOR TEST PROGRAM ANCHOR CREEP AT SELECTED LOAD LEVELS ANCHOR RP-1	
<small>FOUNDATION INVESTIGATION AND TEST PROGRAM EXISTING LOCKS AND DAM NO. 26 ST LOUIS DISTRICT, CORPS OF ENGINEERS. DACW43-78-C-0005</small>	
Woodward-Clyde Consultants <small>VTG825 Phase II</small>	Fig. 4.12
